Demonstration of a Control Algorithm for Autonomous Aerial Refueling (AAR)

(PROJECT "NO GYRO")

FINAL TECHNICAL INFORMATION MEMORANDUM

AIR FORCE FLIGHT TEST CENTER
EDWARDS AIR FORCE BASE, CALIFORNIA
AIR FORCE MATERIAL COMMAND
UNITED STATES AIR FORCE

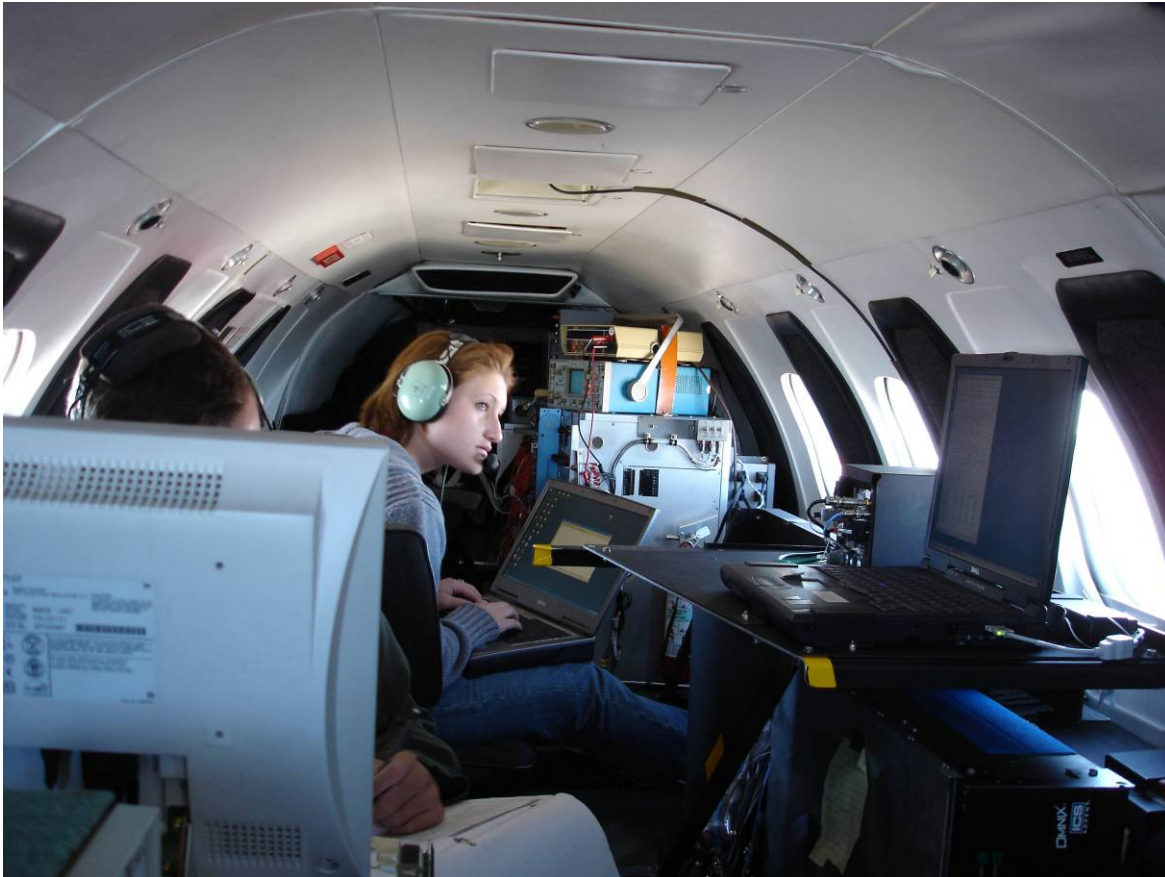
Figure 5. DGPS, VSS, and Crew Stations in the Learjet

The system under test (SUT) consisted of equipment on both aircraft. On the lead aircraft (C-12C), the system included a datalink antenna, datalink transceiver, GPS receiver, Micro-Electro-Mechanical System Inertial Measurement Unit (MEMS IMU), and a PC-104 computer with differential GPS software and a laptop display. Modifications are explained in detail in references 3 and 4. On the trail aircraft (Learjet), the system included a datalink antenna, datalink transceiver, GPS receiver, PC-104 computer with differential GPS software and a laptop display, software installed in the Variable Stability System (VSS) of the Learjet, and a pilot display of current and commanded positions, mounted on the instrument panel.
